Energy Efficiency and Zero Carbon Advice

St Stephen's Church, Colchester PCC of St Stephen's Church

Author	Reviewer	Audit Date	Version
Paul Hamley	lan Shellard	21 st January 2023	1.0

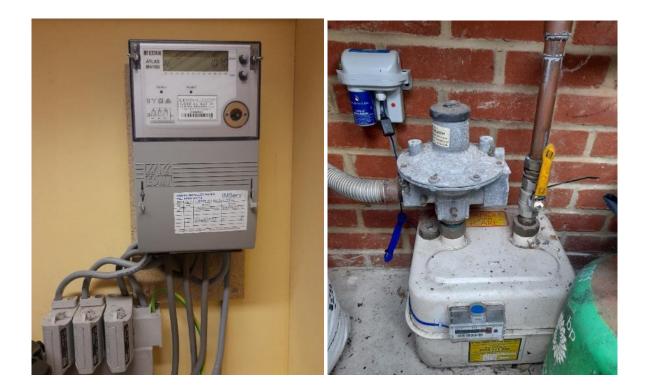
All the meters are AMR connected and as such an annual energy use profile for the site could be obtained from the supplier for gas. Some detailed consumption data is supplied for electricity.

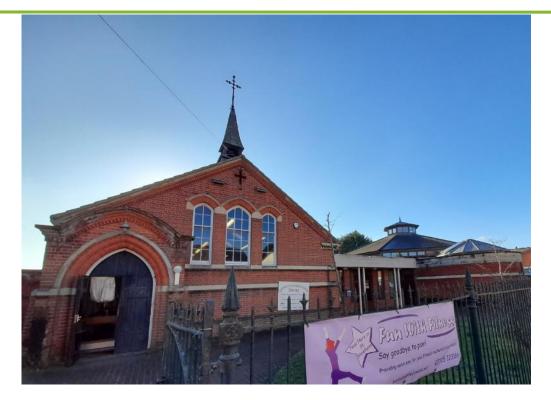
View with the 1902 hall to the left, which has its own independent entrance. This allows parallel, separate events to be held. To the right of the main entrance into the central foyer is a chapel which also has an independent entrance.

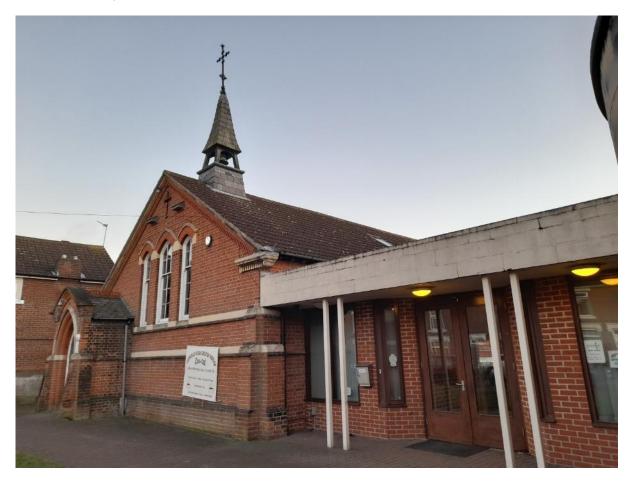
The entrance to the main foyer.

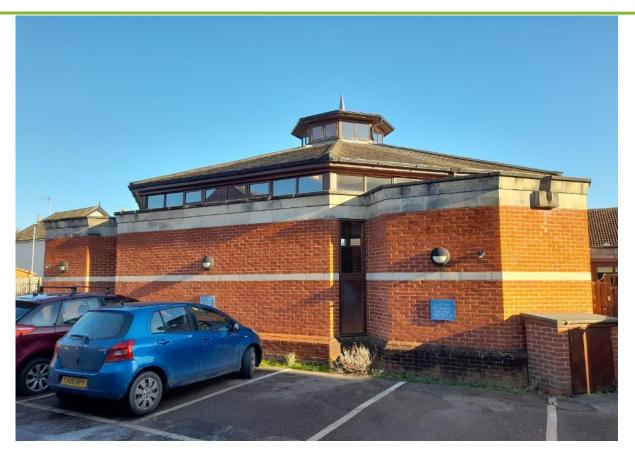
The worship area is surmounted by an octagonal cupola. Two of the eight sides lead to storage areas, one (above, right) containing the boilers.

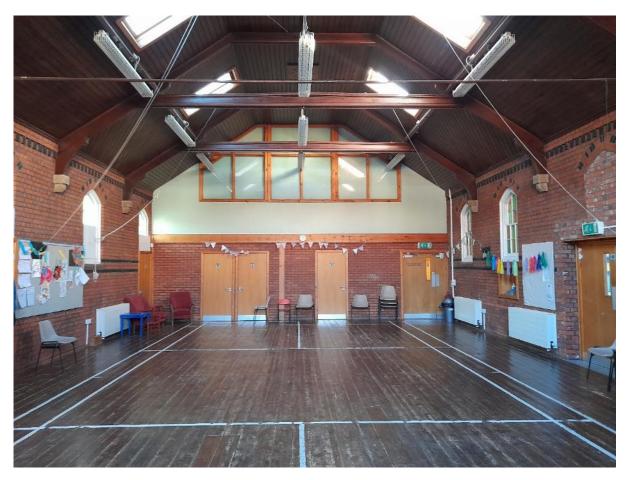
The 1902 hall has been subdivided with a mezzanine floor inserted at the south end which contains a room used for pilates classes.

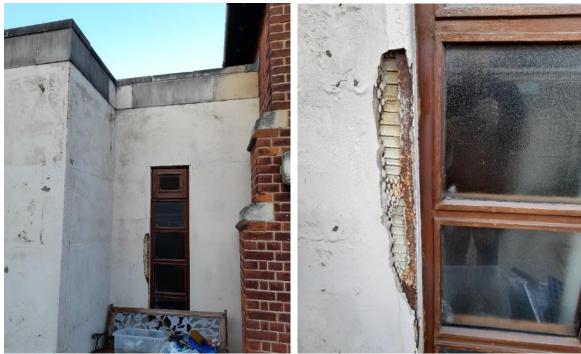
The sanctuary, which has an octagonal form is believed to have structural weaknesses at the eight corners.

The reasons leading to the problems are outside of the scope of this energy audit, but the issue of damp and water penetration which lead to greater energy use (as a result of the extra energy required to vaporise the water emanating from the wall surfaces) is relevant.

The church is embarking on a program of fundraising and remedial works which are likely to involve re-roofing and re-capping the walls in a water tight manner.

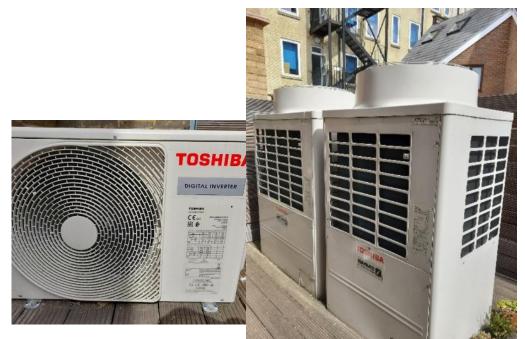
Four of the 3kW input units below left (installed in 2012) supply one floor of an office of area 165m². These are the small, individual units which serve one or two internal units.

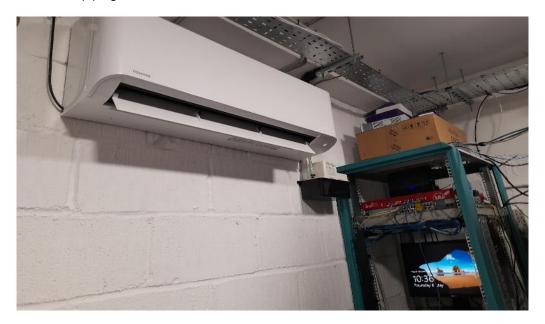
The two large units (each 10kW input, 37.5kW output) serve 500m² of building over three floors via a network of piping.

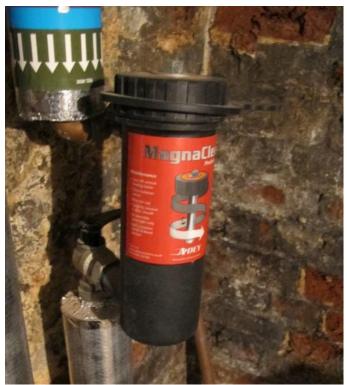
One product is the Lascar EL-USB-2

A temperature and relative humidity datalogger should be purchased. This can be used to help identify areas which are suffering from damp (and hence to inform the rebuilding project), and also to help understand, manage and reduce energy use by monitoring temperatures.

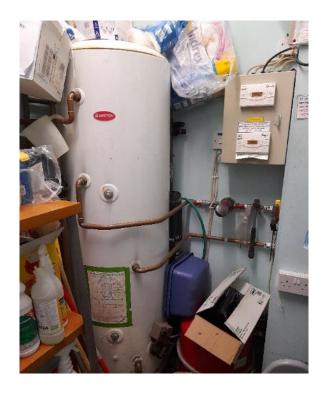
The current 300 litre tank appears to be sized to supply the shower room – which was described as never being used.

If showering facilities are required in future following heat pump installation, an electric shower should be provided.

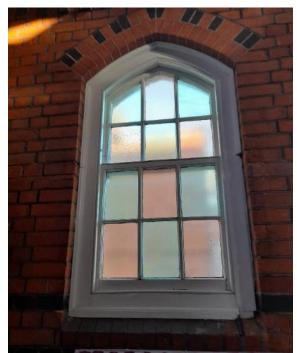
Internal secondary glazing could be added to the wooden frame using acrylic sheet, attached by magnetic adhesive strips. There are companies who will supply sheet cut to size.

This would be at low cost (compared to ~ $\pm 500/m^2$ for framed glass internal glazing units) and are removable (they are held in place by magnetic strips with adhesive backing).

It is recommended that secondary glazing is installed.

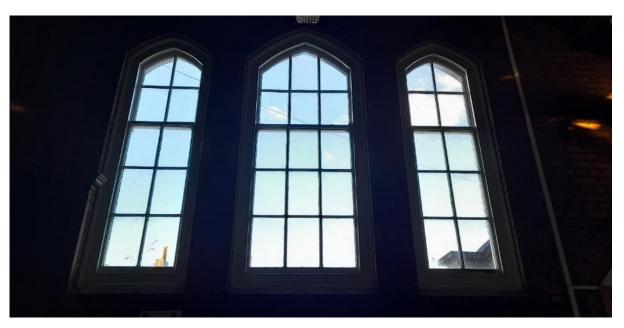
Secondary glazing should also be applied to the street facing three light north window of the hall.

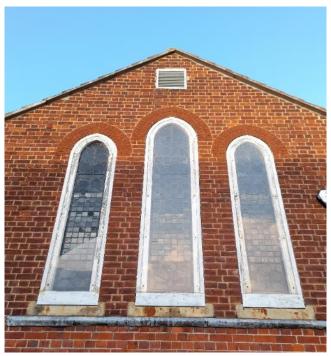
The south facing three light windows have been externally secondary glazed. One of the glazing panels (left) is broken and should be replaced. UV Protected polycarbonate sheet should be used (this prevents yellowing and prolongs lifetime). "Axgard" is one such product.

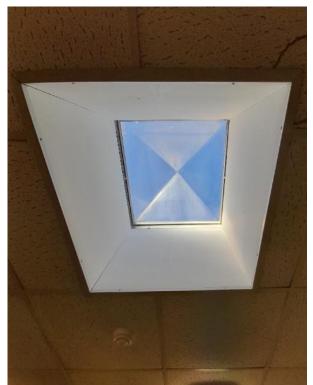
Skylights can import more light if the vertical portion is lined with highly reflective material. "Light pipes / light tubes / tubular skylights" incorporate collectors (covers) whose geometry maximises incoming light. The church may wish to consider incorporating these into the reroofing project for the centre to serve toilets and the rear passageway. This would reduce the amount of lighting needed, but only if the lights are controlled by presence detectors which also incorporate light sensors.

- As well as taking the opportunity of roof and wall repairs to ensure that the "new" building is effectively insulated, if the roofing is completely replaced, the skylights could be replaced by light pipes. If the skylights themselves are retained, fitting light pipe reflective tubing underneath to bring extra light down through the structure is recommended.
- There are various maintenance interventions needed to reduce draughts.
